The Newsletter of the Colorado Riparian Association

Volume 15, Number 2, Summer 2004

Burlington Mine Site Voluntary Cleanup: An Ecologically-Based Approach to Mine Site Remediation

by James B. Cowart¹, P.E.; Julie E. Ash², P.E.;
Warren C. Rider³

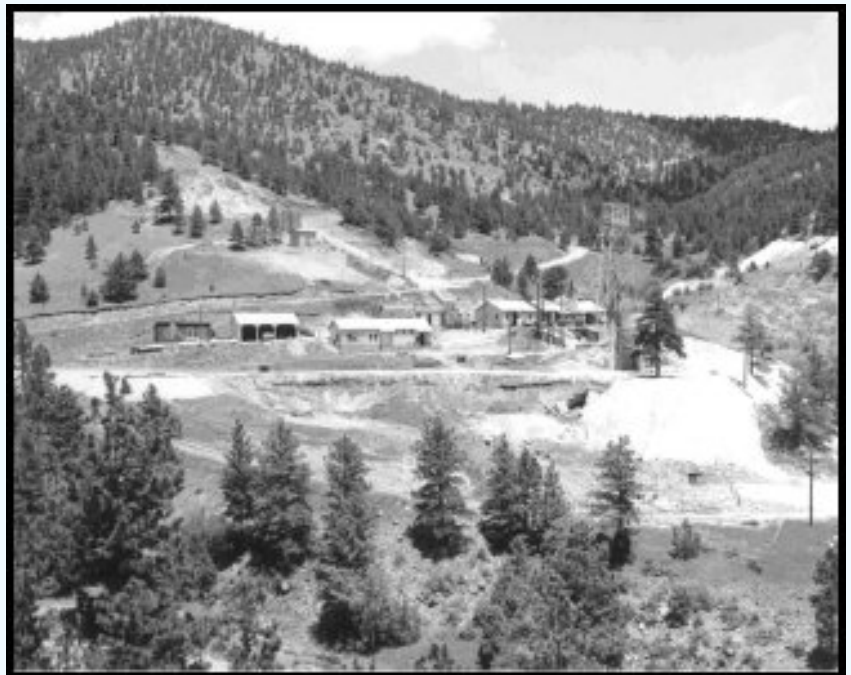
*Photo 1: Burlington Mine circa 1962, courtesy of
Denver Public Library*

Mine was part of the chief fluorspar-producing district for the western United States. Photograph 1 shows a historical photograph of the mine site circa 1962. The Burlington remediation was conducted under the Colorado Department of Public Health and Environment's Voluntary

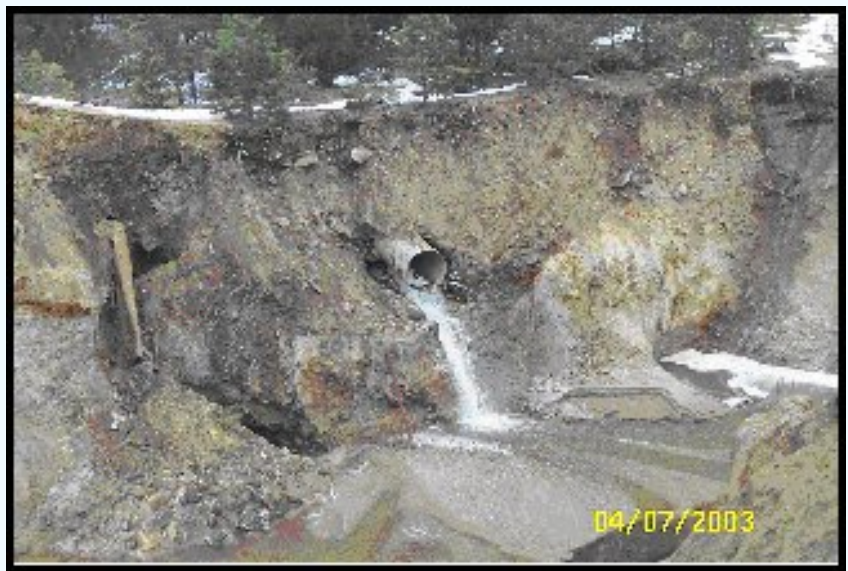
Photo 2: Direct flow path of Balarat Gulch into mine workings under existing conditions

Under existing conditions, the subsidence pits were providing direct flow paths into the mine workings. Of particular concern was the pit that intercepted Balarat Gulch, an intermittent drainage that drains to Little James Creek and ultimately to Left Hand Creek -- see photograph 2. Backfilling this pit was the first step in eliminating the direct flow path for the gulch into the mine workings. Final grading included substantial mounding over the backfilled pits to create a minimum two percent slope. The positive slope created by the mounding discourages infiltration -- and potential contact with mine workings -- by promoting runoff. In

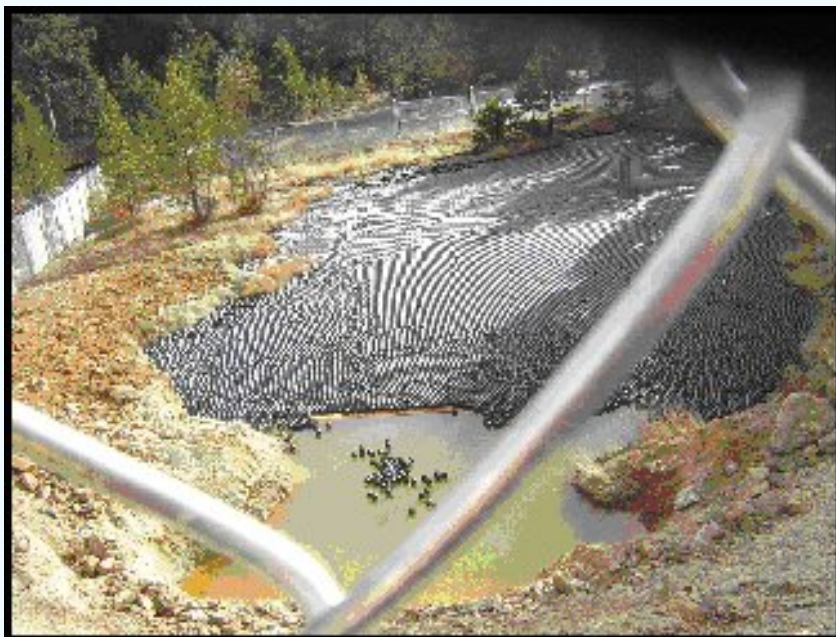
Photo 3: Bird Ball™ installation to protect waterfowl

While the pond and its discharge had to be excluded from this VCUP project due to point source discharge issues, concerns for the health of waterfowl that would be tempted to land in the pond were addressed. Bird Balls™, which were recommended by the U.S. Fish and Wildlife Service, were used to cover the pond surface, preventing waterfowl from landing or residing in the pond, and removing potential contamination pathways. Photograph 3 shows the Bird Balls™ covering the mine pond.
